THE  
ONTARIO WATER RESOURCES  
COMMISSION  
WATER POLLUTION SURVEY  
VILLAGE OF JARVIS

APRIL - 1965

ONTARIO WATER RESOURCES COMMISSION

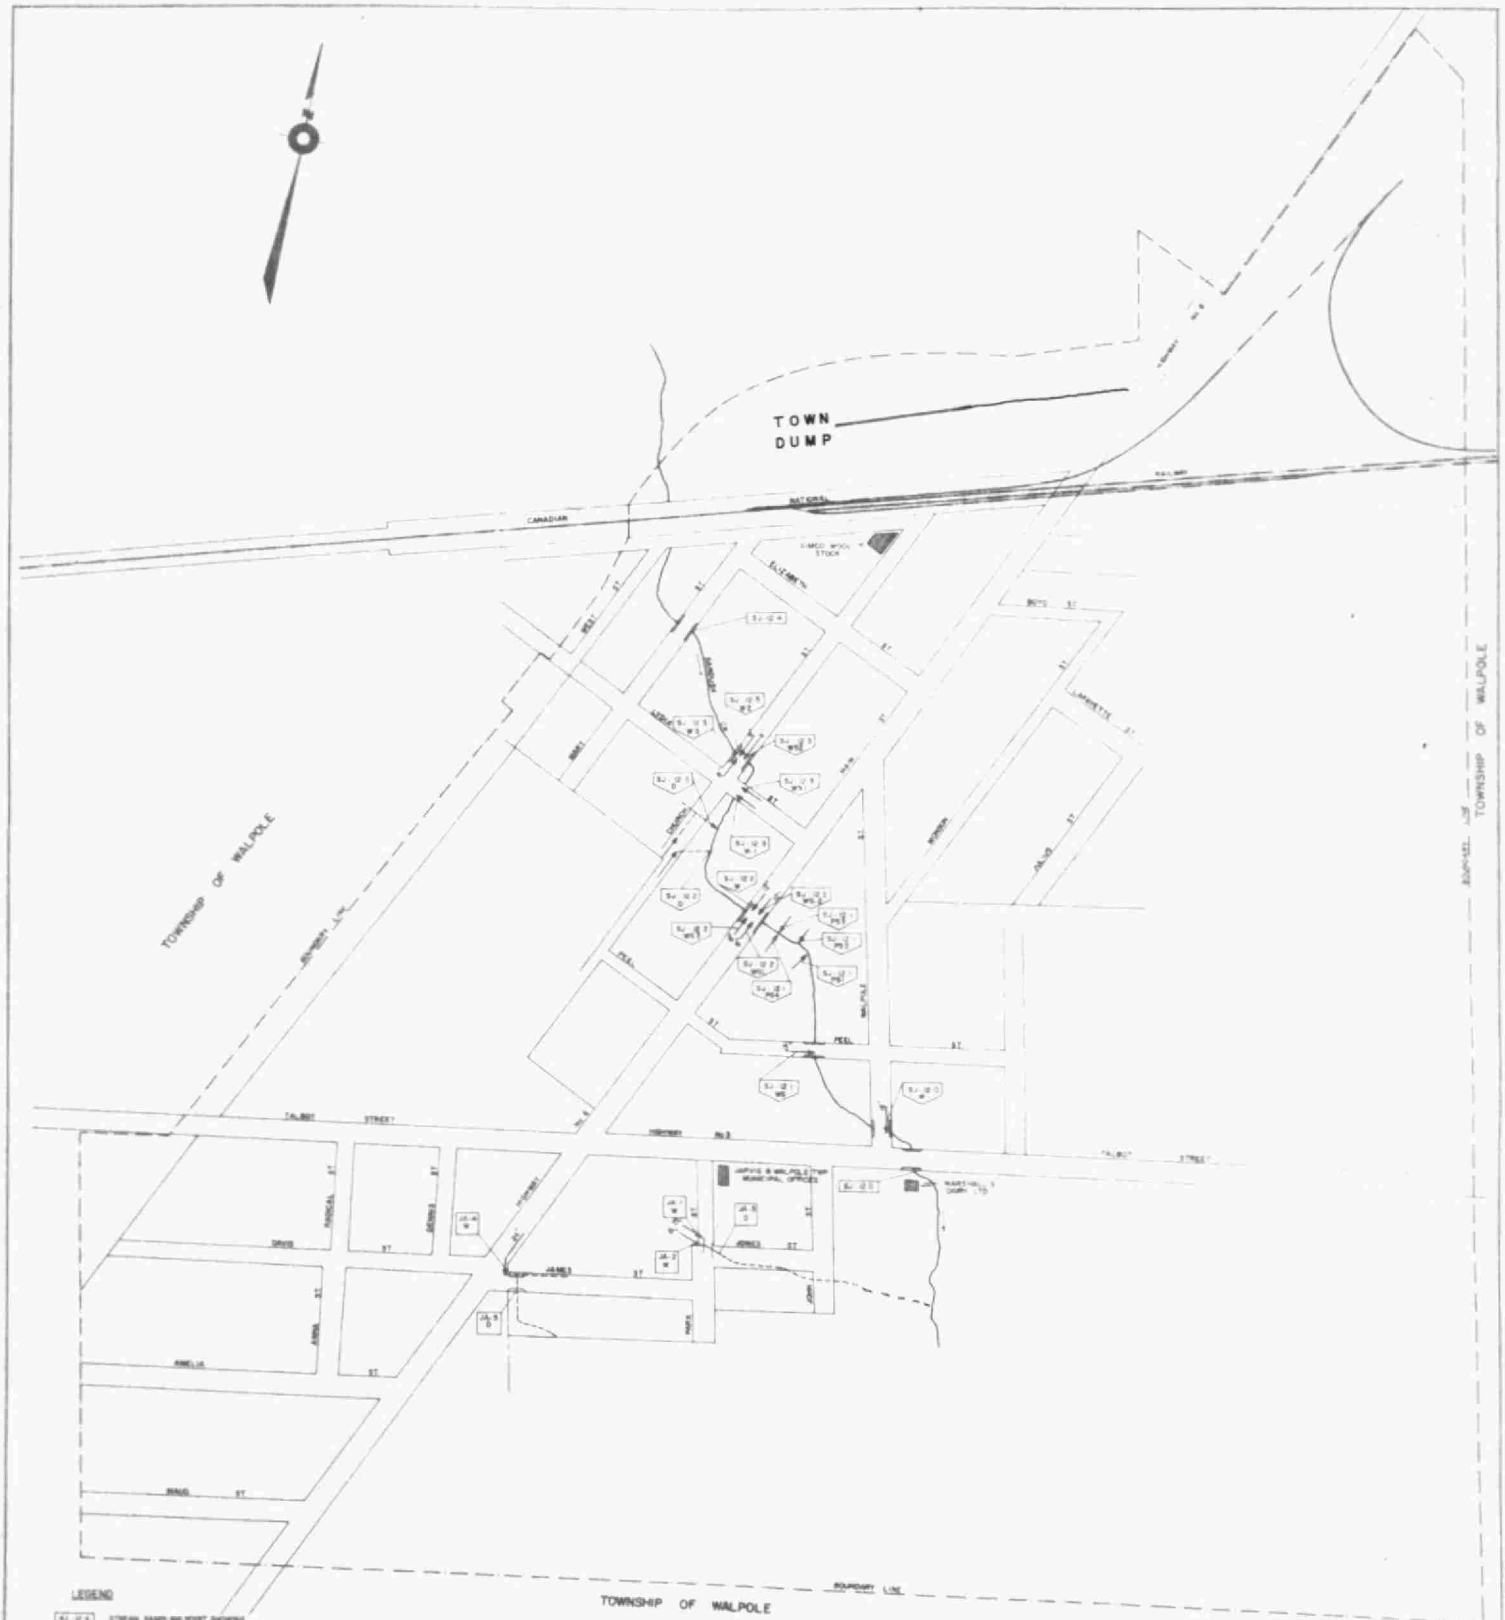
FIG 8  
**VILLAGE OF JARVIS**  
**WATER POLLUTION SURVEY**  
 COUNTY OF HALDIMAND  
 SCALE  
 0 200 400 FEET  
 ONTARIO WATER RESOURCES COMMISSION  
 TORONTO JAN 1962 1A  
 DWG No 60-3-4

Grab samples were taken from all flowing discharges to the creek as well as from the creek downstream of the village. Included in the appendix is a list of all the outfalls located, the laboratory results, as well as an interpretation of the analyses performed. Reference should be made to the appended plan of Jarvis for location of the outfalls and sampling points.

The BOD and coliform count of the samples from the Peel St. storm sewer and the drainage ditch (JA-3-D) were in excess of the Commission objectives. These results were indicative of raw sewage. The analyses of samples collected at SJ-12.0 and SJ-11.1 should be compared to the Commission objectives of 4 ppm and 2400 organisms

per 100 ml respectively for BOD and coliform organisms. The latter sample which was taken one mile downstream from the village shows evidence of gross contamination. This is attributed to the numerous waste discharges to the creek in the Village of Jarvis.

1. The Village of Jarvis should seriously consider the provision of both water and sewage works.
2. Preventative measures should be taken in order that the refuse disposal area does not contaminate the local watercourse.
